**Flood Control Project Maintenance
Levee Inspections**

Fall 2013 Levee Maintenance Deficiency Summary Report

San Joaquin River Basin

Reclamation District No. 2096 Wetherbee Lake

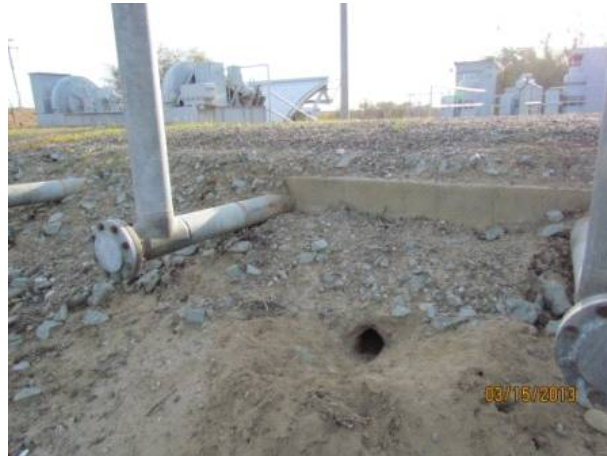
Levee Mile Report Line	4
Start Levee Mile	0.02
End Levee Mile	0.02
Location	Water Side
Category	Earthen Levee
Item	Animal Control

View of the rodent burrow on the waterside levee slope.

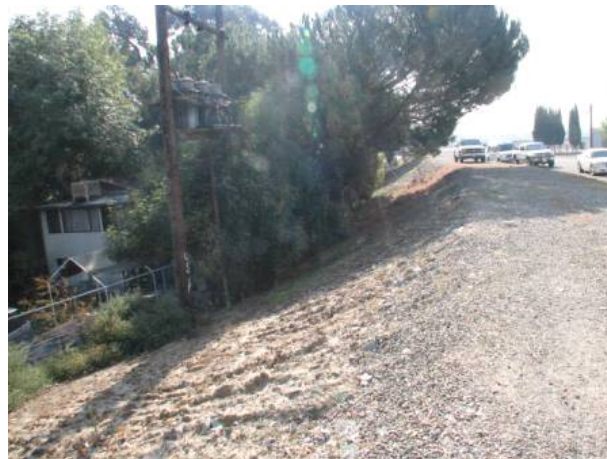
Levee Mile Report Line	5
Start Levee Mile	0.04
End Levee Mile	0.17
Location	Land Side
Category	Earthen Levee
Item	Encroachments

11/09/2011 Fence at the toe of the levee.

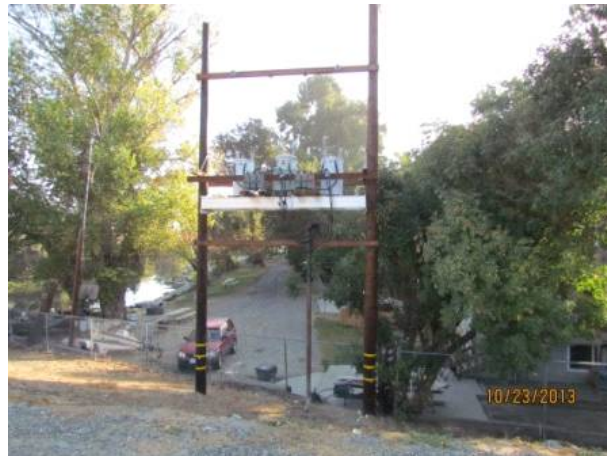
Levee Mile Report Line	6
Start Levee Mile	0.05
End Levee Mile	0.05
Location	Land Side
Category	Earthen Levee
Item	Encroachments

View of the telephone poles at the landside levee toe.

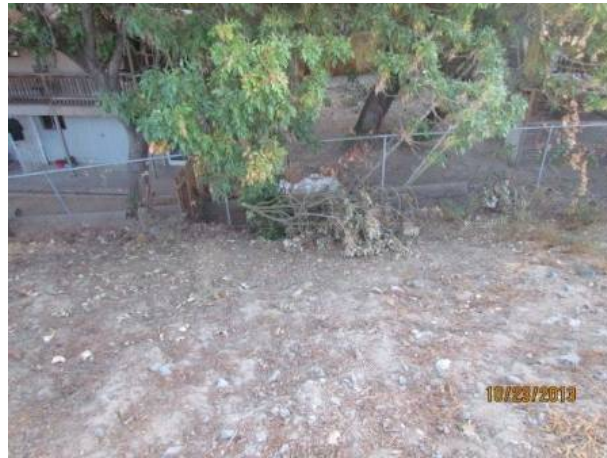
Levee Mile Report Line	7
Start Levee Mile	0.07
End Levee Mile	0.07
Location	Land Side
Category	Earthen Levee
Item	Encroachments

View of the prunings at the landside levee toe obstructing visibility and access.

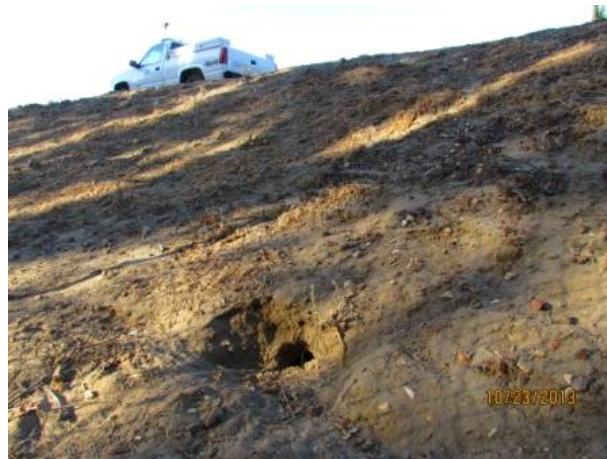
Levee Mile Report Line	8
Start Levee Mile	0.09
End Levee Mile	0.09
Location	Land Side
Category	Earthen Levee
Item	Animal Control

View of the rodent burrow on the landside levee toe.

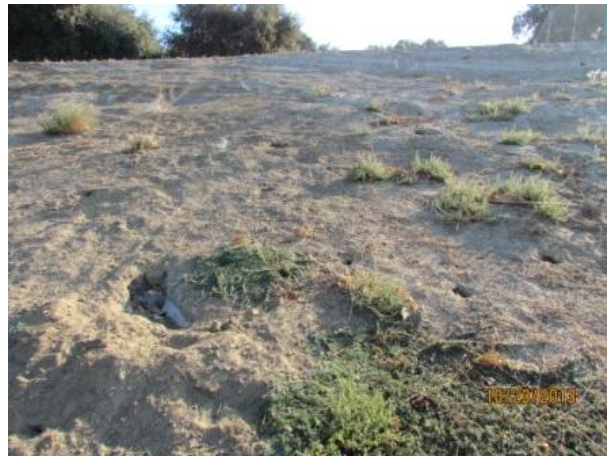
Levee Mile Report Line	10
Start Levee Mile	0.12
End Levee Mile	0.12
Location	Water Side
Category	Earthen Levee
Item	Animal Control

View of the multiple rodent burrows recently grouted on the waterside levee slope. Monitor and exterminate any remaining rodents in the area.
